Site 1 - Before Reclaim

SCI Reclaim Services

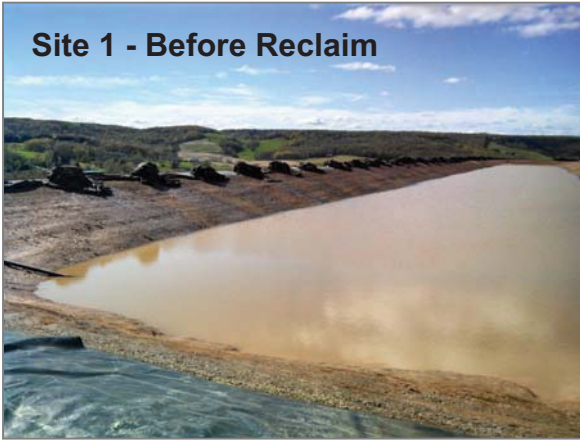
Photo 1 – Removing Liner. We had to deal with significant amounts of ground water during the reclaim process of this impoundment.

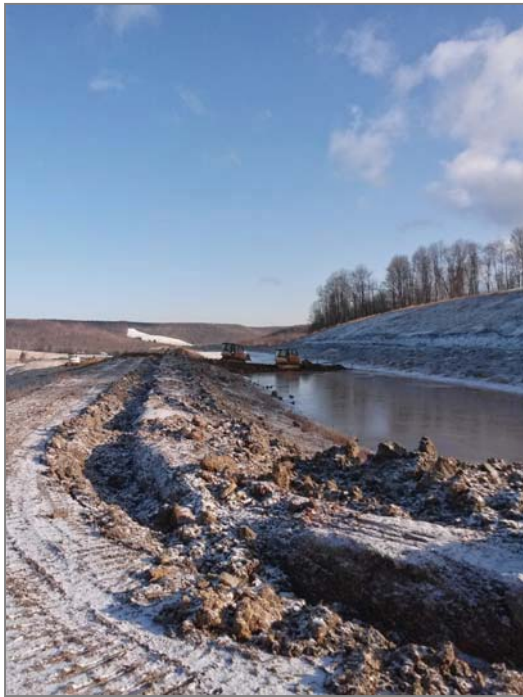
Photo 2 – Dividing the impoundment to help manage incoming water. All water had to be collected / recycled during the reclaim process.

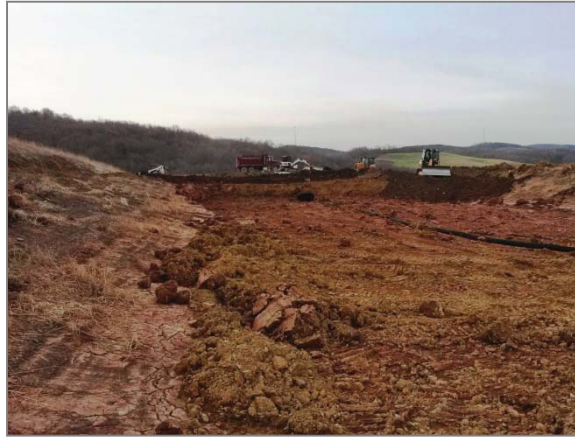
Photo 3 – Installing DEP approved field drainage system. We recommended a field drainage system be installed to prevent any future problems for the property owner due to the amount of ground water draining into the area.

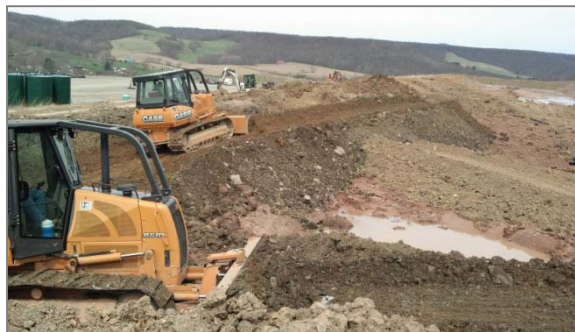
Photo 4 – This project consisted of moving approximately 25,000cy of earth.

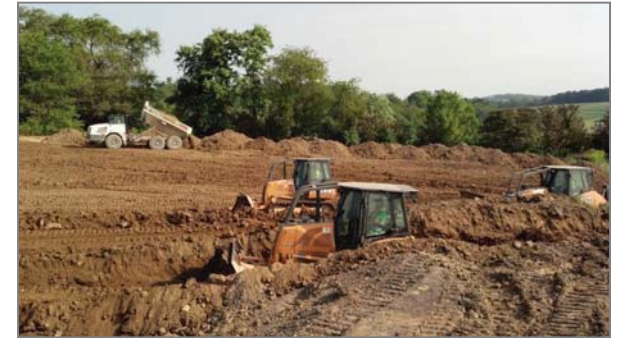
Photo 5 – Hauling and spreading topsoil before seeding.

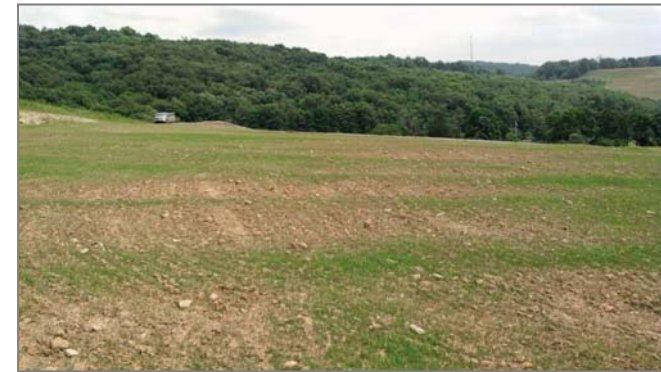
Photo 6 – Impoundment closed in and seeded.

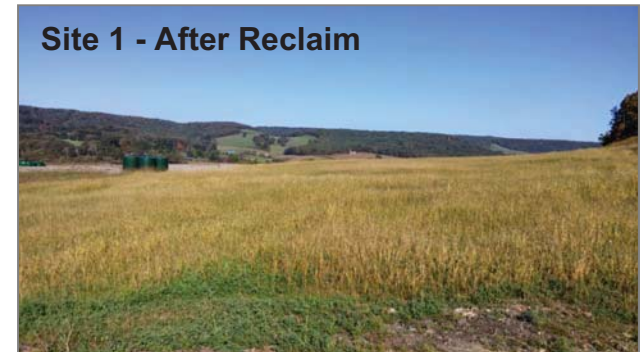
Site 1 - After Reclaim

Photo 7– Reclaimed impoundment. Standing at the same location as Photo 1.
